DØ Silicon Microstrip Tracker for runlla

Eric Kajfasz (CPPMarseille)

Vertex2002 - Hawaii, November 4, 2002

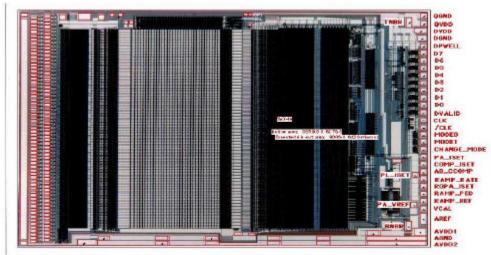
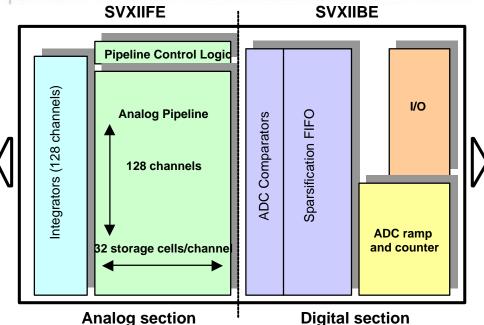
SVXIIe chip

- 1.2 um CMOS amplifier/analog delay/ADC chip fabricated in the UTMC rad hard process
- Designed by LBL/FNAL
- Some features:
 - 128 channels
 - 32 cell pipeline/channel
 - 8-bit Wilkinson ADCs
 - Sparsification
 - 53 MHz readout
 - 106 MHz digitization
 - 6.4 x 9.7 mm2
 - **●** ~ 85,000 transistors
 - noise: 490e + 50e/pF

To Readout System

To Silicon Detector

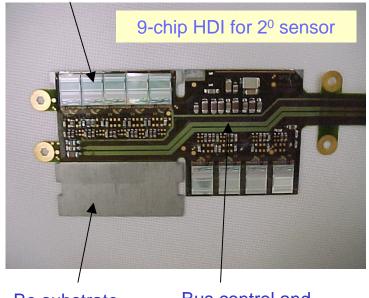
High Density Interconnect

- Kapton based flex circuits with 0.2 mm pitch for chip mounting
- Laminated to Beryllium substrate and glued to Silicon sensor
- Connects Sensor to SVXII
 chips and SVXII chips to flex
 circuit via wire bonds
 (Al wedge bonding)
- Connects to a Low Mass Cable which carries the signals out of the interaction region

SVXIIE chips

Be substrate

Bus control and power traces

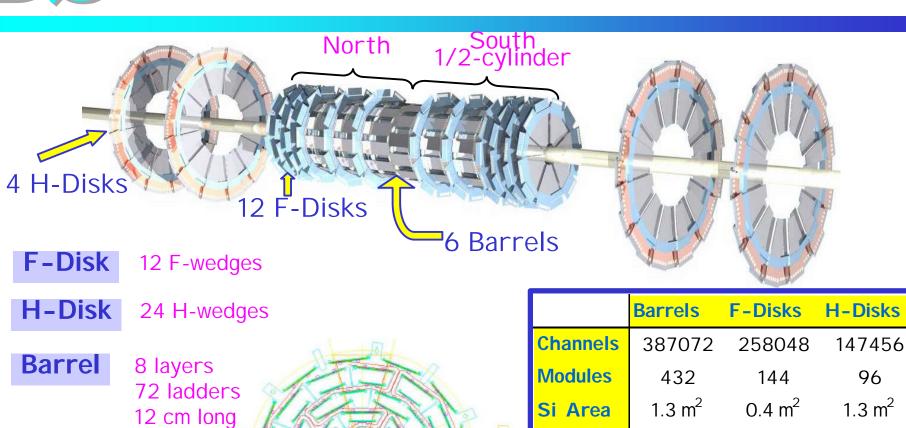
Runlla SMT Design

Layers 1,2,5,6: L3 or L6 Layers 3,4,7,8: L9

6192 R/O chips = 792,576 channels > 1.5 million wire bonds

Inner R

Outer R

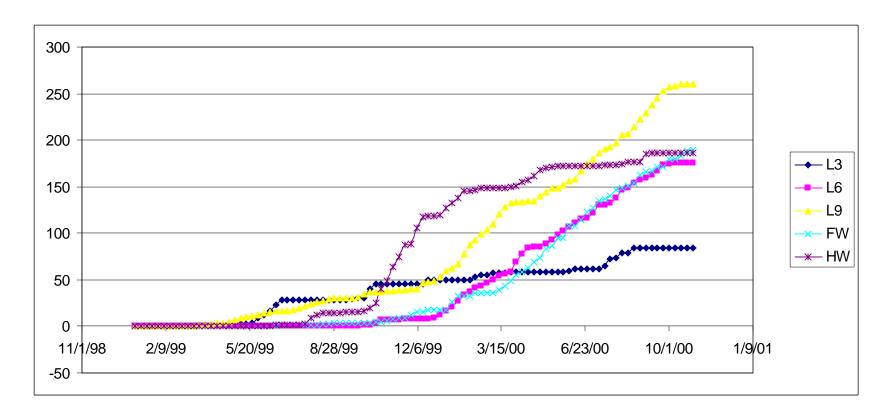
Production: Rates

Production mainly paced by problems with HDIs and Silicon sensors (yields, delivery delays ...)

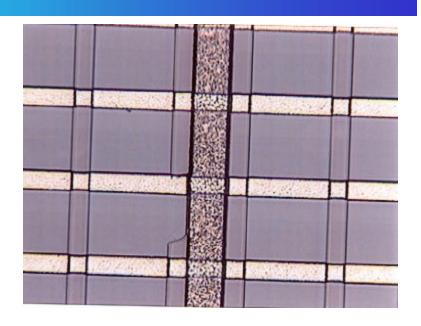
Sensor lithography defects

A silicon manufacturing problem produced p-stop isolation defects in the 90° stereo ladders. This resulted in a 30% yield from the manufacturer.

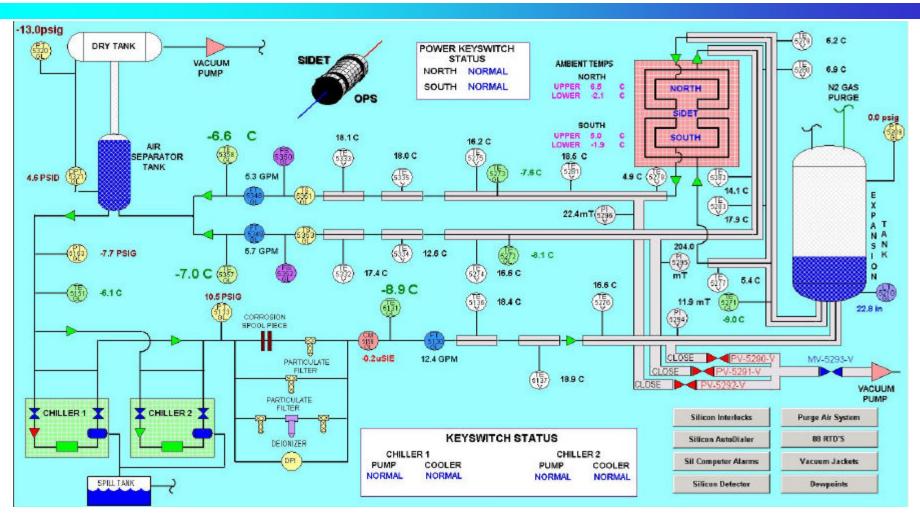
Installation: Cooling system

- 30% glycol + water at -10 °C (=> detectors between -5 and 0 °C)
- The tracking volume is purged with dry air to prevent condensation

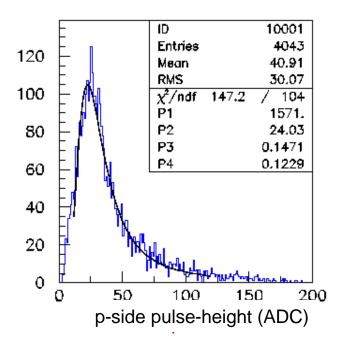
Commissioning: Charge collection

Cluster charge (corrected for track angle): 1 mip ~ 25 ADC counts. Noise < 2ADC counts.

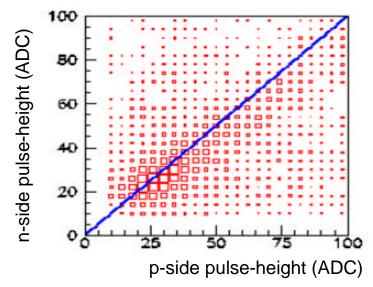
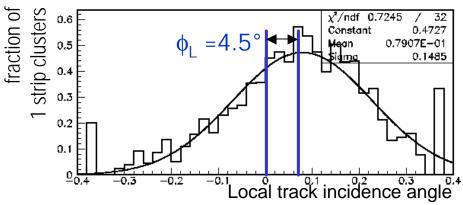
Lorentz angle: The charge deflection due to the magnetic field Charge correlation between pand n-side of a detector

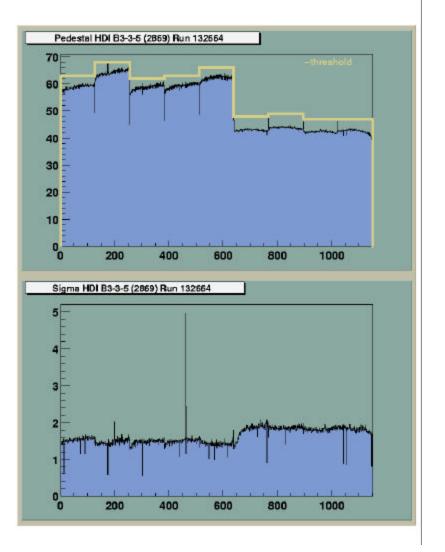
Operations: Calibrations

- SMT pedestal, noise and gain measurements are taken using SDAQ.
- Pedestal and noise measurements are used to calculate the threshold per chip to be used in sparse read out

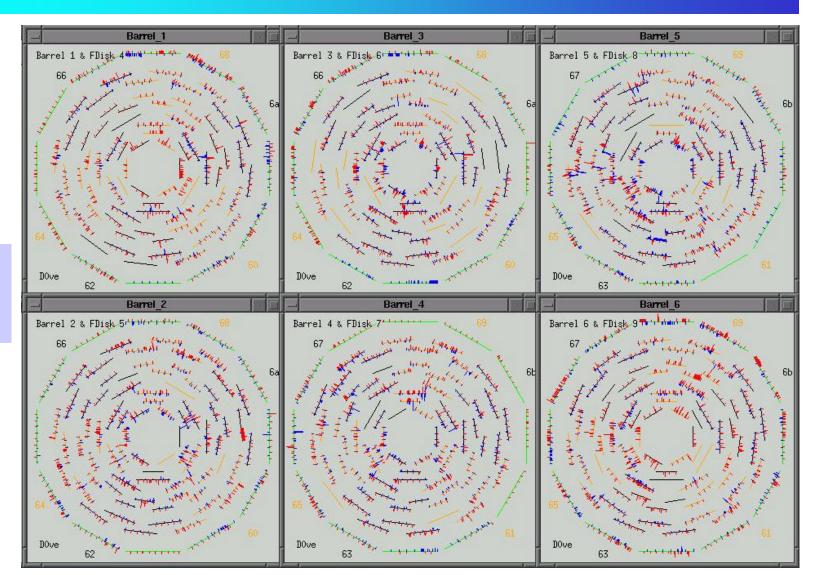
a quiet event

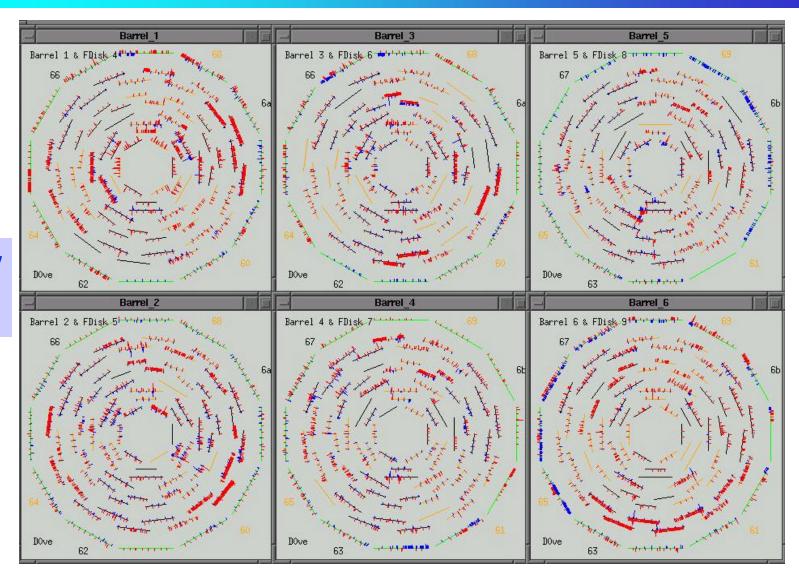
a busy event

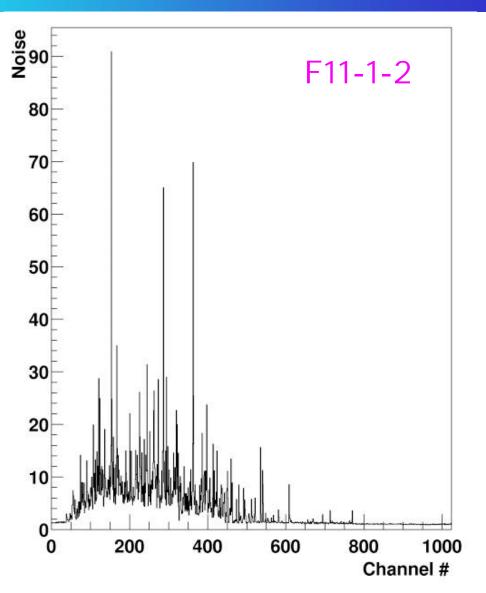
Operations issues: F-Wedges noise (1)

- seems to affect only the p-side of a fraction of the Micron sensors
- does not seem to depend on the biasing scheme
- does not seem to depend on temperature
- still investigating ...

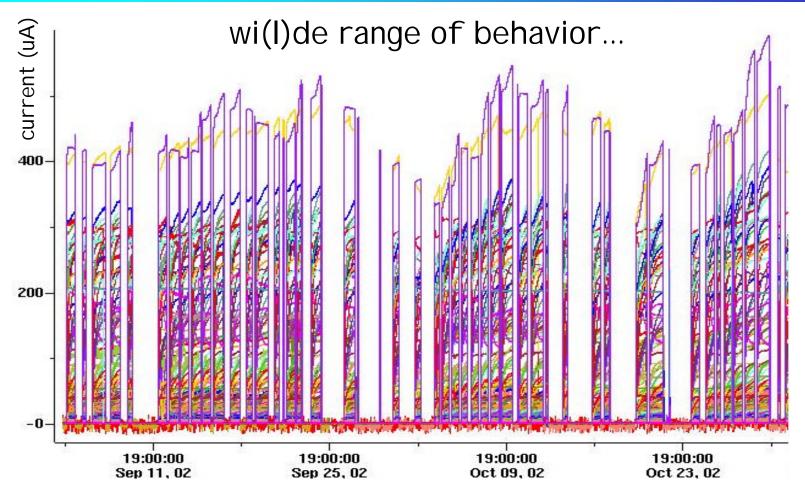
Bias currents: first look (1)

this is not bulk current.
